# Ares I-X DFI Lessons Learned Colin Brooks EV33/Jacobs

Thermal & Fluids Analysis Workshop TFAWS 2011 August 15-19, 2011 NASA Langley Research Center Newport News, VA

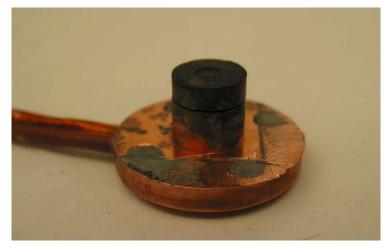
- Schmidt-Boelter type with type K thermocouple mounted next to thermopile
  - Medtherm model 20850
- Performance
  - Sensor temperature measurements worked well (only lost one late in re-entry)
  - Only one high flux gauge failed
- Lessons Learned
  - When in doubt, specify higher range gauge

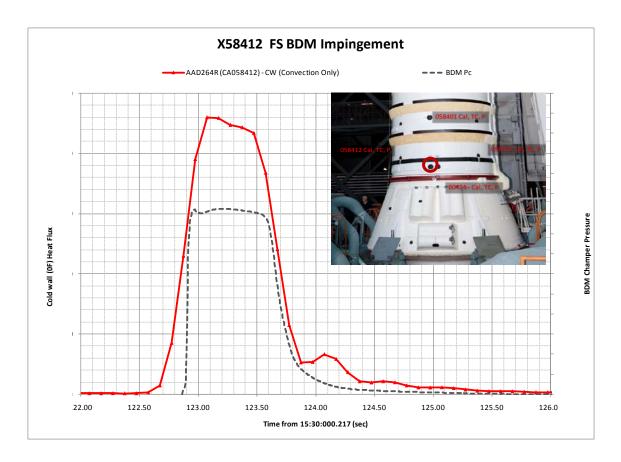
- In high heat flux areas:
  - Gauges were ranged correctly
  - Most functioned and survived

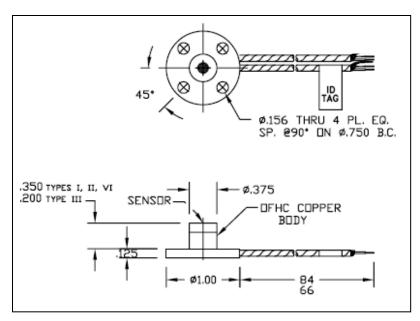
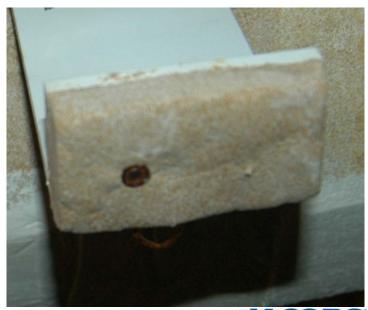
- Calorimeter with a sapphire window
  - Medtherm model 20850
- Performance
  - Mortality rate higher than desirable
- Lessons Learned
  - GN<sub>2</sub> purge required to mitigate contamination (Al<sub>2</sub>O<sub>3</sub> or other) and allow acquisition of mid-to-late flight data

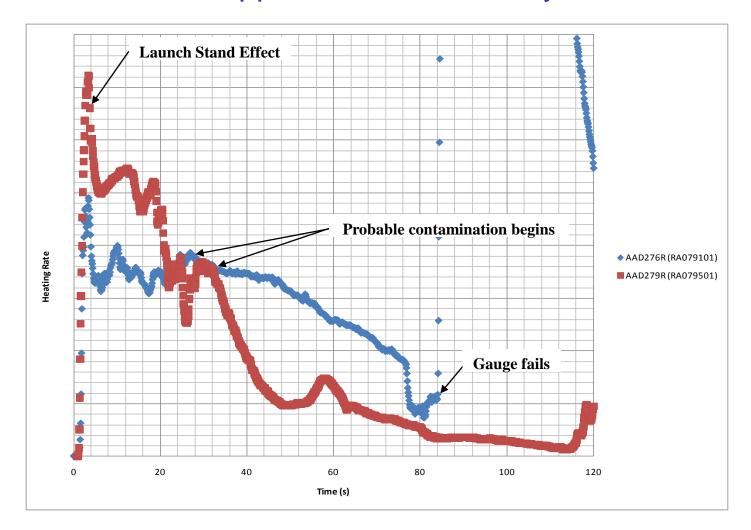
All radiometers appear to fail eventually

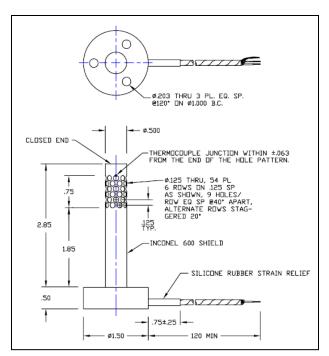
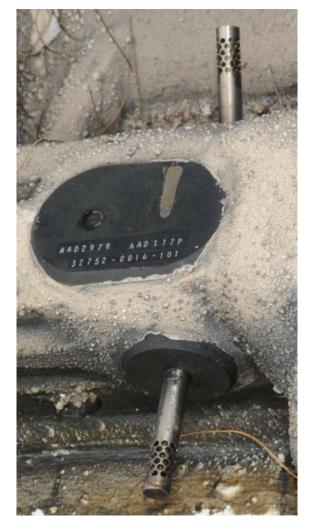
- Base Gas Temperature Transducer
  - Medtherm model 11190
- Performance
  - All gauges functioned
- Lessons Learned
  - Must account for radiation losses

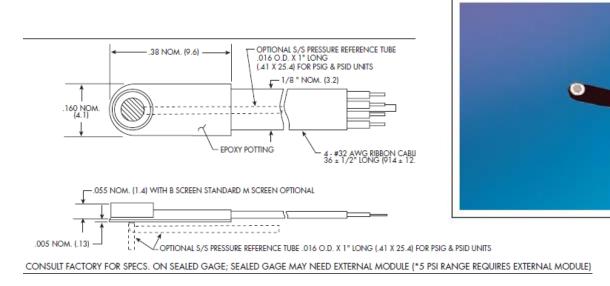
- Thin Line IS Pressure Transducer
  - Kulite LL-080 Series
- Performance
  - Gauge type and installation were not tolerant to significant heating
- **Lessons Learned** 
  - 0-20 psi gauges provided the necessary level of fidelity

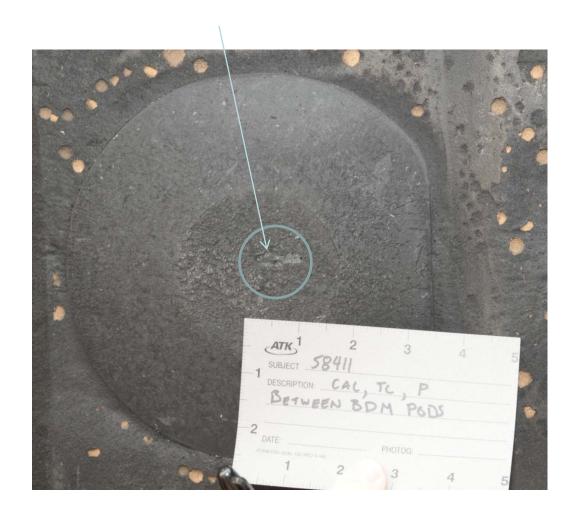
The gauge was completely burned out by the BDM firing.

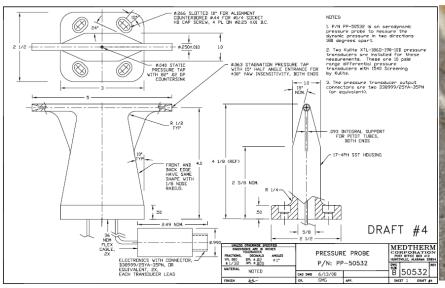
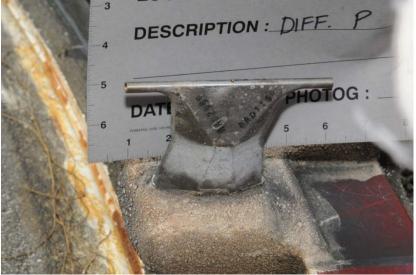
- Flow direction probes
  - Medtherm model 50532
- Performance
  - Newly designed, functioned well
- **Lessons Learned** 
  - May interfere with other gauges: shock heating to nearby calorimeter

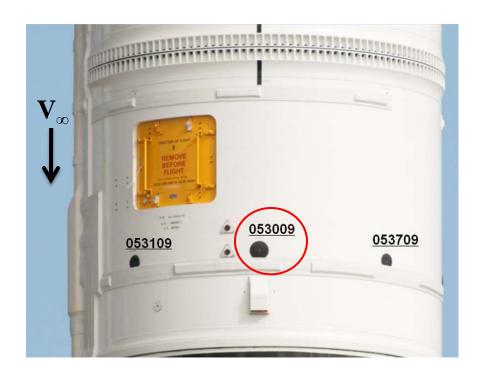
- Ensure there are a few true clean skin calorimeters
  - Measured heating amplifications due to proximity of cork runs near gauges
  - Below, separation occurs over the protuberance due to cork run / antenna

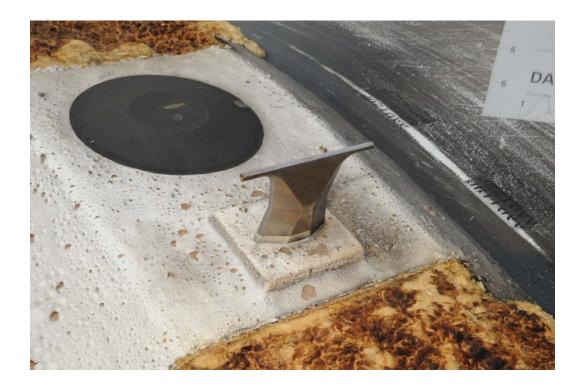
Avoid instrument interference/installation effects (e.g. instrument island in the proximity of the flow direction probe)

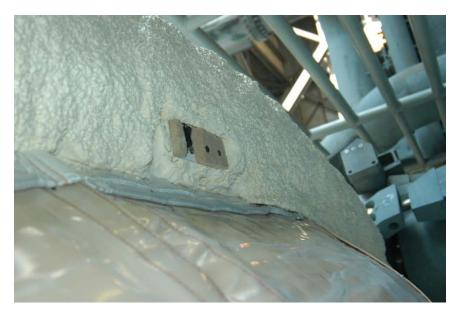
- One of the groups of gauges similar to this set was completely foamed over during close out operations.
  - No data was acquired from those gauges.

- Clearly specify installation procedures
  - Foam trimming, etc.
  - Need to have person on-site for some critical installation steps such as last minute foam application
